4/10/15 Geomorph Trip  
~62°F 9:15am JMU Campus

Overcast/Patchy sun/Windy  
Purpose: Site assessment (Phase) of  
Sitebert Run; Looking for evidence  
of instability  
- Changes in landuse  
- Evidence of stability/instability  
- Evidence of erosion

4/17/15

Purpose: Look for signs of restoration of Black's Run. Compare to Siebert Run.

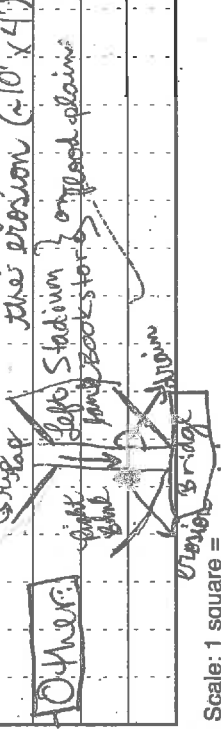
Bed Material: Concrete

Stream shape: straight; narrow  
~1.25'; straightened by humans

Erosion: The "channel" has been cut  
up higher from higher floods, too small (on either bank)  
patches of rock w/ wire trying to control

Ramifications: - Velocity increases;  
steepened gradient  $\rightarrow$  trying to scour;  
wants to downcut, but put concrete  
down

- Concrete needed to be patched up  
w/ concrete mixed w/ rip rap  
- Drain (see pic) concentrating the  
energy from the runoff water onto  
one site on the right bank  $\rightarrow$  leading  
to extra erosion of that spot

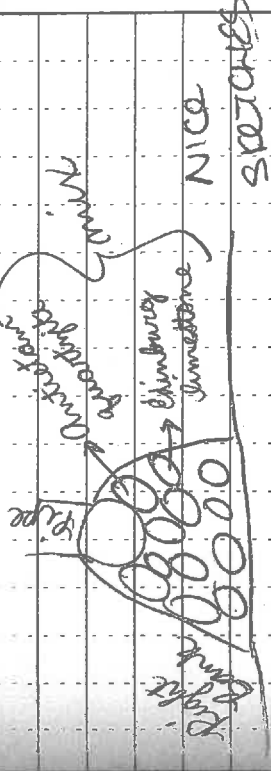
NICE SPACES  
Left bank  $\rightarrow$  debris line of  
leaves = recent high  
water

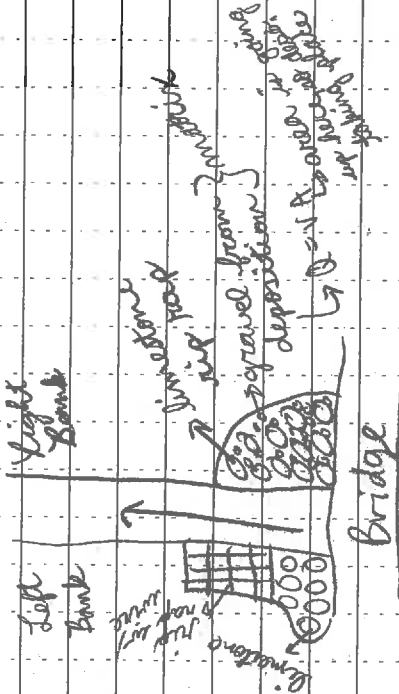
- lip rap → causes hungry water + scours further down the stream

- 2 generations of R.R. here: the larger boulders by the bridge + the finer, wire covered stuff

- large boulder plucked up + fell in stream

- Evidence of erosion: manhole cylinder exposed; hole under sidewalk

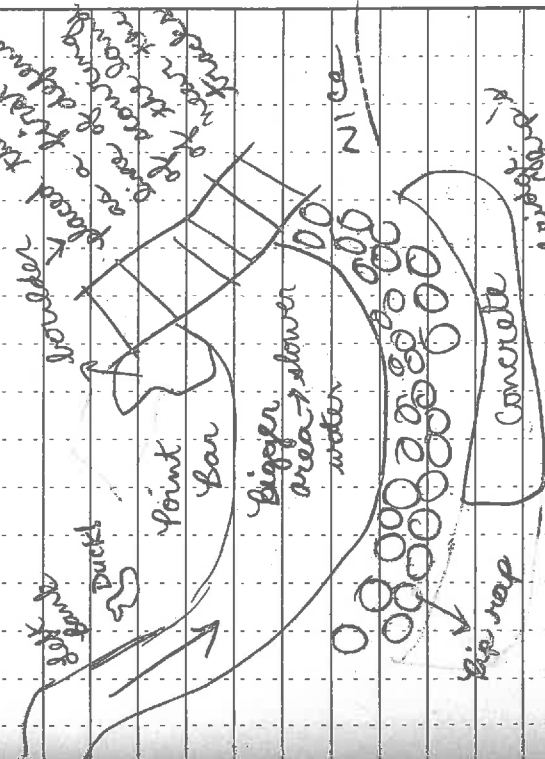
- Natural meanders back

→ stream encouraging erosion

→ cut bank

- sediment finer

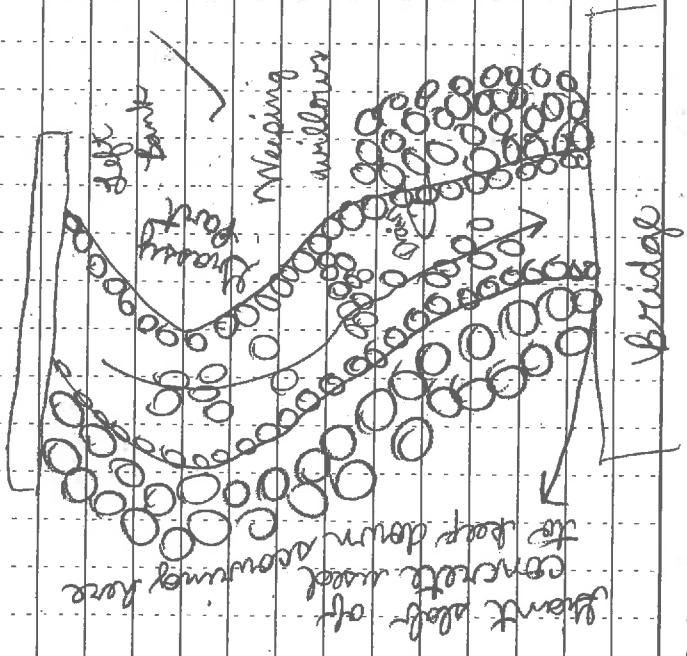
- lots of rip rap

- some plucked loose + fell in stream channel ✓  
- Kickpoints present  
- several pipelines

↳ more erosion near these  
↳ floodplain moved down from chip's to where some of the rip rap is

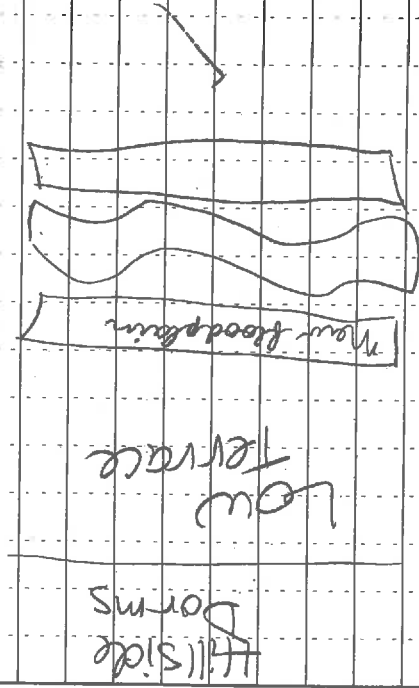
- Giant concrete wall.
- Very stagnant
- Rock ledge coming out from right bank
  - ↳ called J-Hooks; wanted to increase sediment movement
- Bad for fish
- Low oxygen; nasty water from runoff

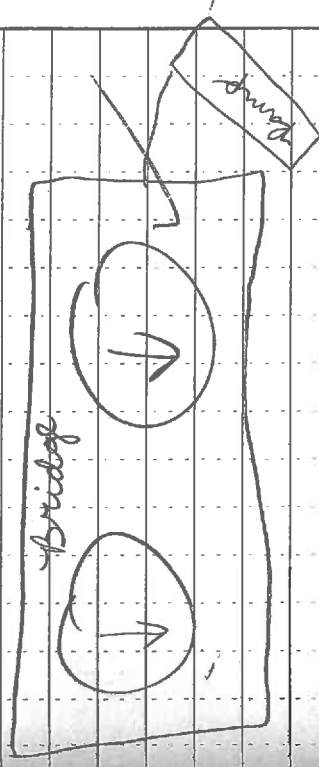
- Water being forced through smaller holes → deeper & c/s scouring from hungry water
- Stream cutting down so much they've had to extend the runoff surface → concrete slab being scoured underneath

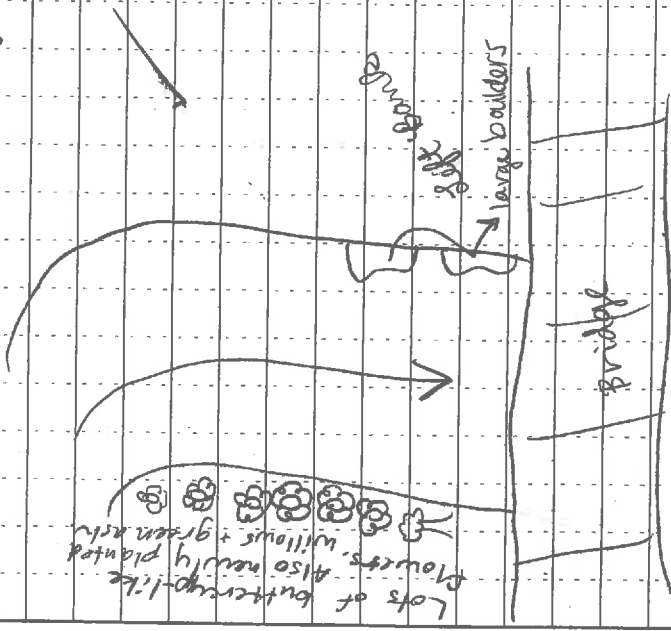
- Large maple on right bank + lots of small ash saplings + jammed into stream bank as raparian buffers

- Downstream even more are V-shaped structures/weirs used to help create riffles; there's one by the rock and a shorter one just a little more downstream

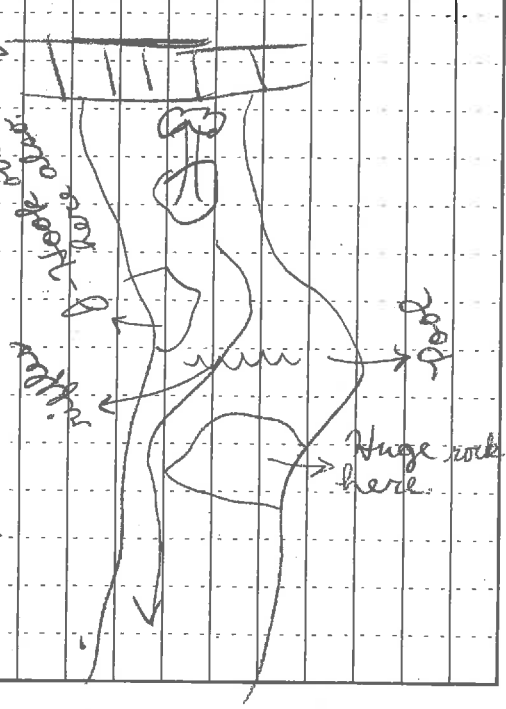
- Is the large slab bed rock or was it  
placed there?

- Not 100% sure, but probably bedrock  
(too large to have been moved there)  
- It's controlling the incision of  
the stream

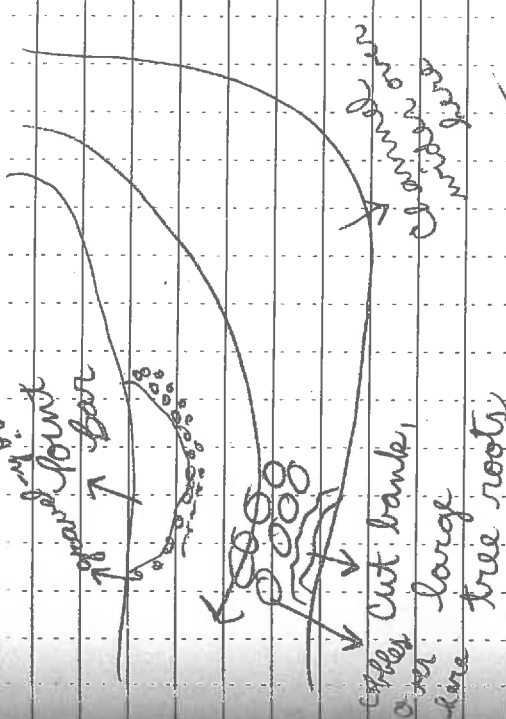
- Why no pool on the cut bank?  
The root systems + cobbles transferring  
the stream

- Black's Run used to be wider.  
Like at this stop → they narrowed  
the channel to help water moving  
+ get the fine stuff out.

- The stream from the narrower spouts  
coming down here + making a  
wider, deeper channel
