Hurricane-induced landslide activity on an alluvial fan along Meadow Run, Shenandoah Valley, Virginia (eastern USA)

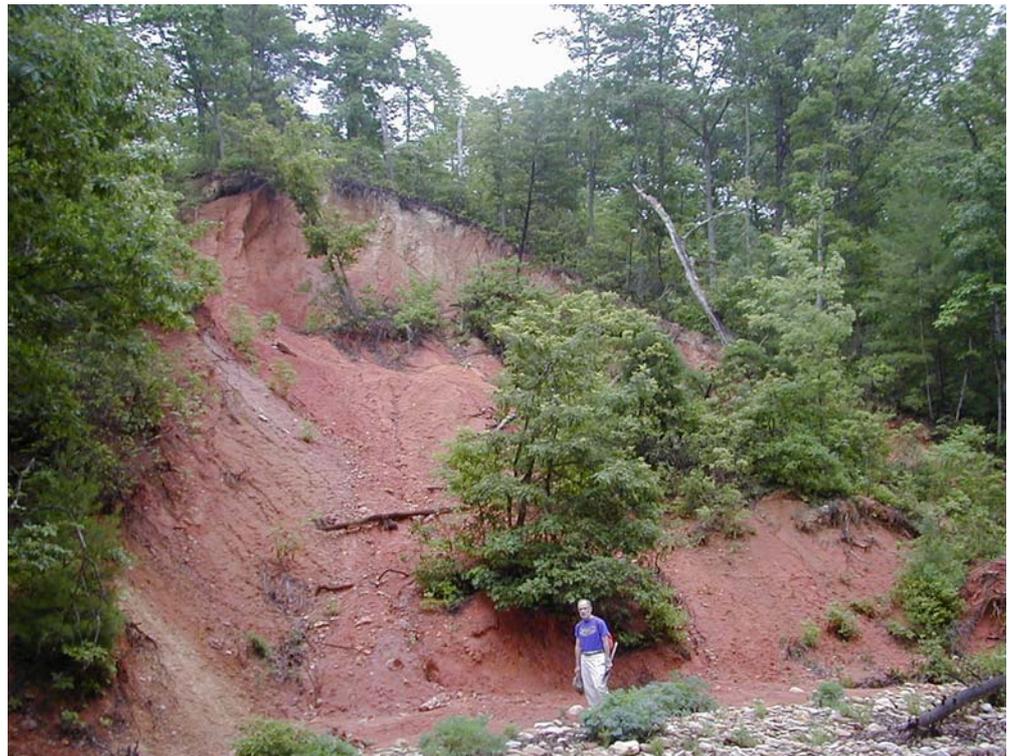
Fig. 4 Upstream landslide (UL) along Meadow Run. Gravel and cobbles at the toe of the landslide were deposited from the stream channel of Meadow Run. Note the deciduous vegetation just above our colleague's head. Photograph taken July 25, 2002. Compare this picture to Fig. 12

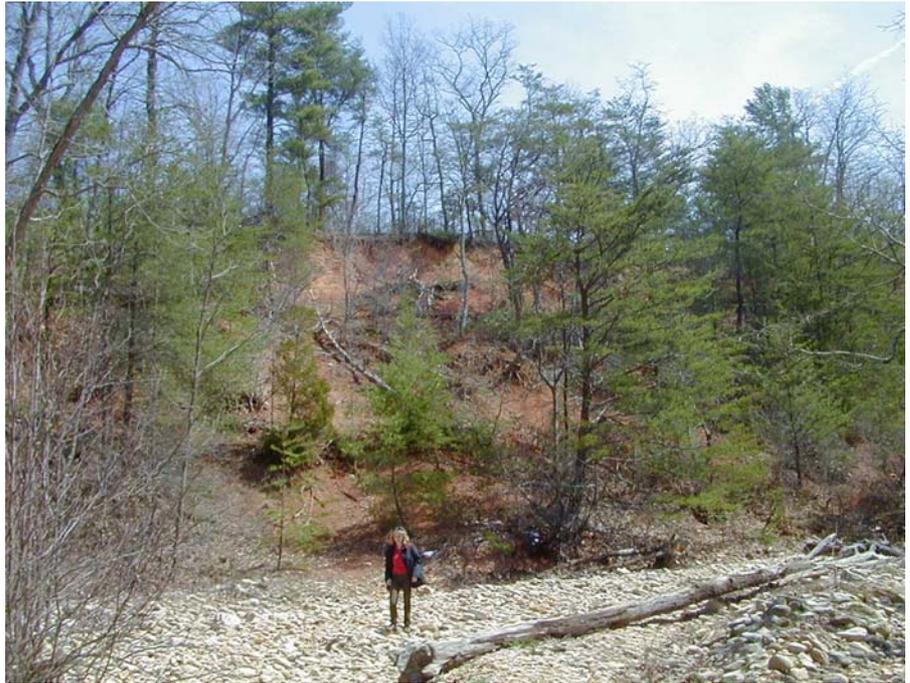
Fig. 5 Downstream landslide (DL) located along Meadow Run. Dry gravel in foreground was deposited in the stream channel of Meadow Run. Photograph taken April 1, 2003

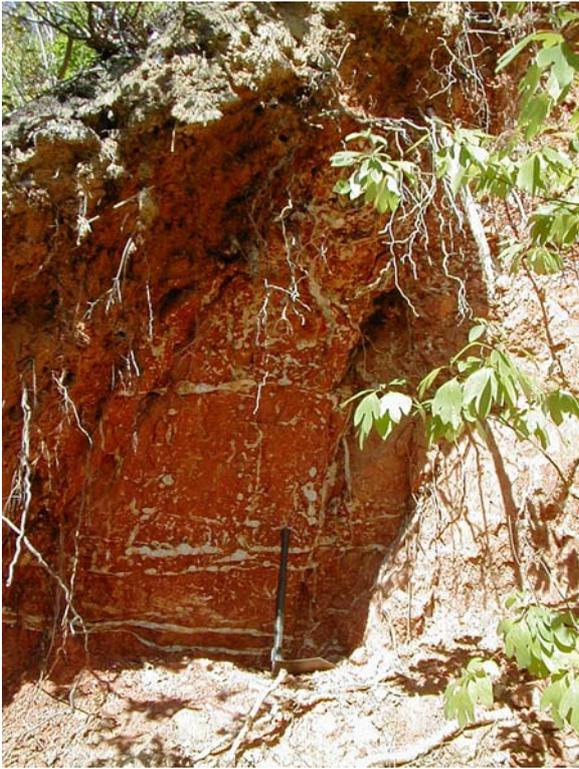
Fig. 7 Saprolite exposed near base of channel below alluvium along northwestern lateral scarp of (UL) landslide

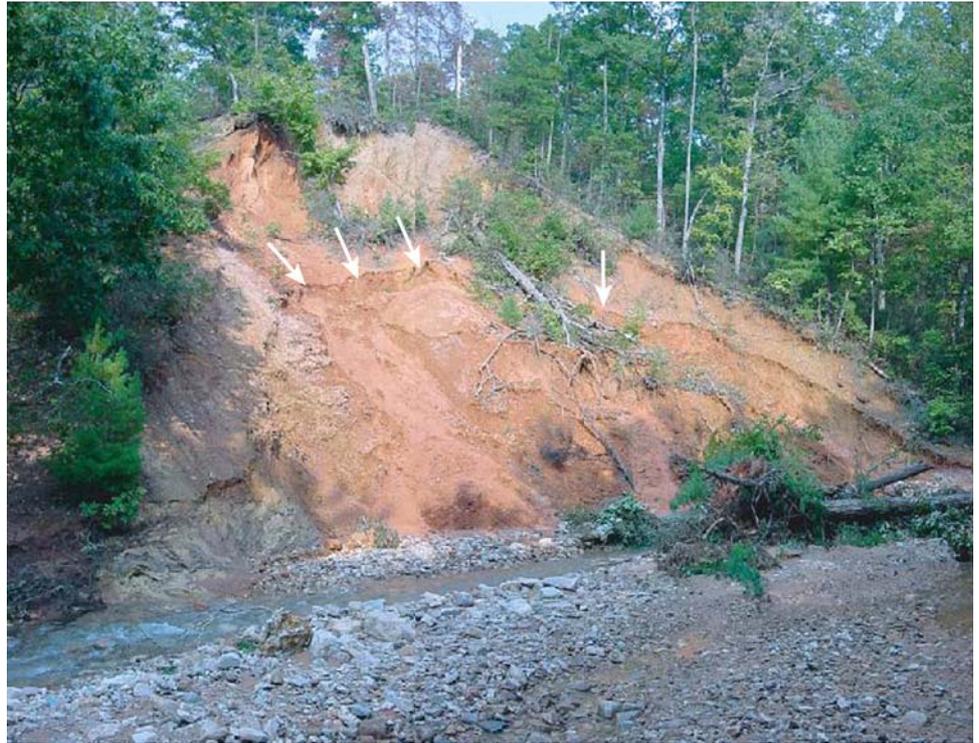
Fig. 12 Upstream landslide (UL) reactivated by Sept. 18–19, 2004 Hurricane Isabel. The new scarp of the reactivated landslide formed midway upslope (arrows). Stream flow of Meadow Run remains near toe of landslide. Photograph taken September 21, 2003

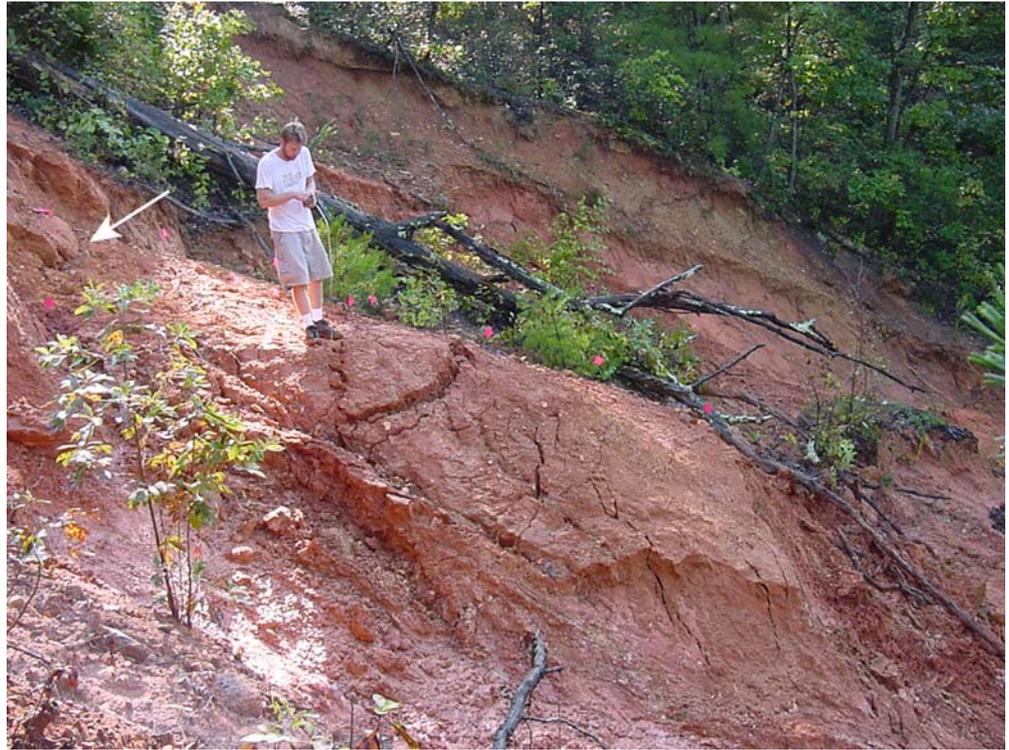
Fig. 16 Four days after Hurricane Isabel, displacement of about 1.3 m was measured on a block (Lower Slope Downstream Side) below the scarp (white arrow). Red flag points had been installed 2 days earlier during which time multiple tension cracks had developed. Photograph taken September 23, 2003
